Buncefield: Why did it happen?

The underlying causes of the explosion and fire at the Buncefield oil storage depot, Hemel Hempstead, Hertfordshire on 11 December 2005

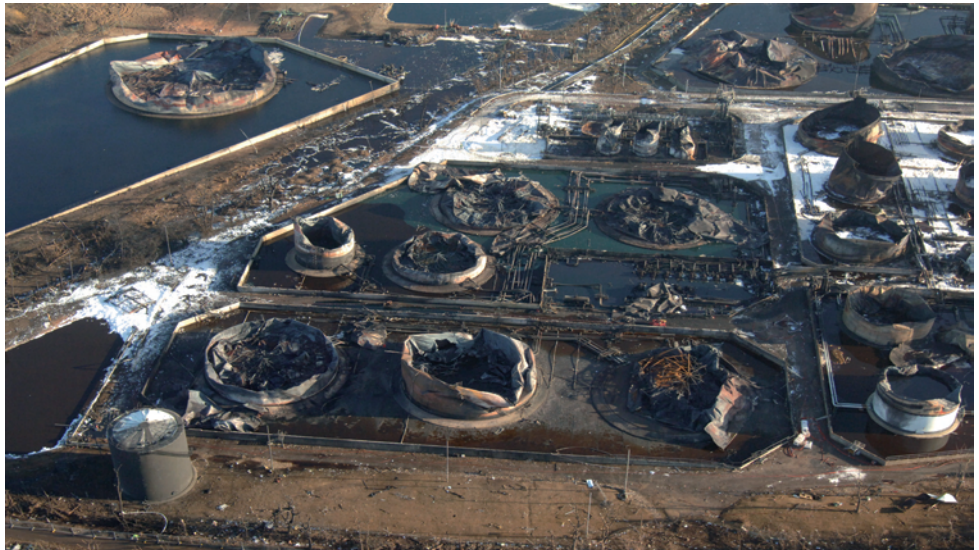
Figure 6 Buncefield after the incident: Tank 912 is in the centre foreground and Tank 12 is in the top left of the picture © Chiltern Air Support

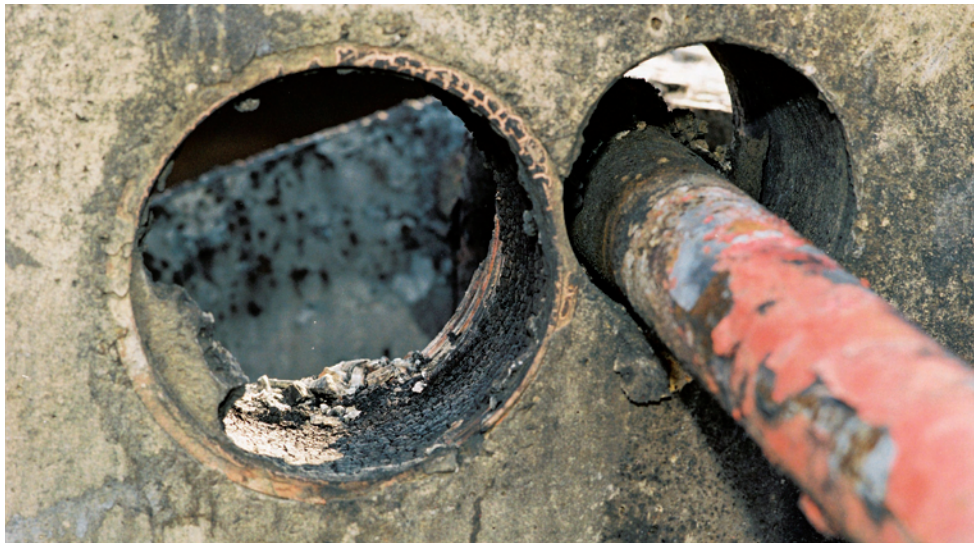
- some of the product pipes leading from the tanks ruptured and leaked so that there was an escape of fuel via damaged pipes through the walls and out of pipes in unbunded areas; and
- loss of seal between pipes and walls.

Figure 9 Loss of sealant between penetrating pipe and bund wall

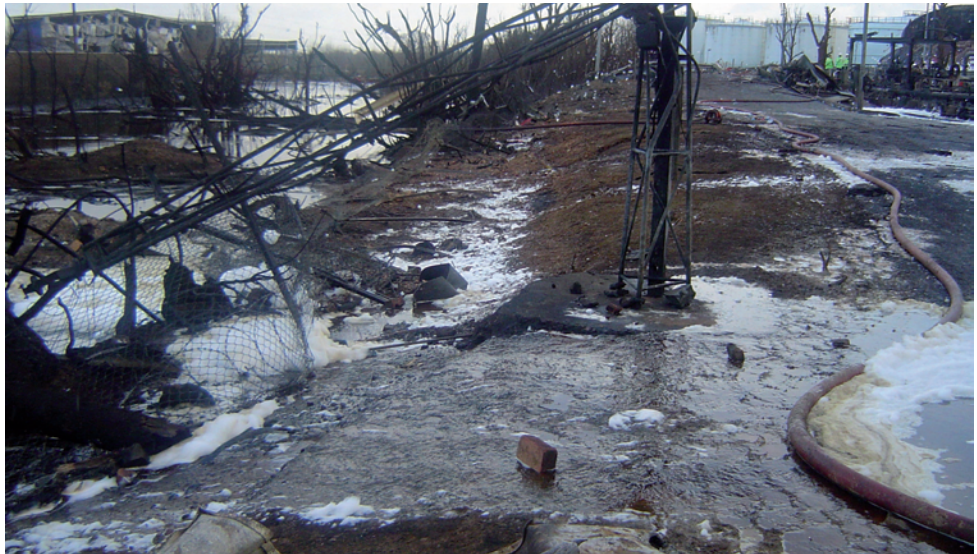
- There was no kerbing or boundary wall/mound to keep liquids on site and direct them into drainage systems. Once released, liquids could flow anywhere.

Figure 10 Fuel and firefighting liquids flowed off site

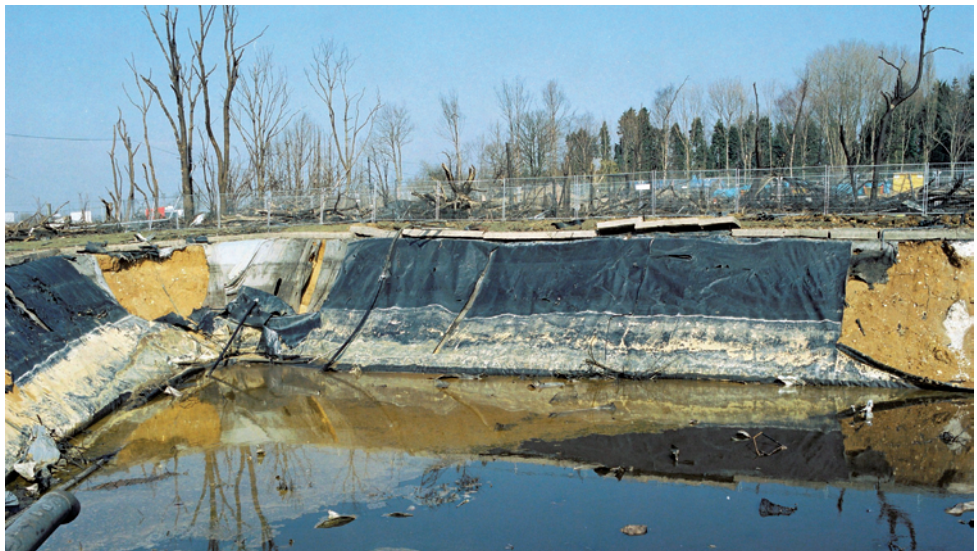
Figure 11 The firewater lagoon on the HOSL site after the incident

- The HOSL West lagoon was intended as a firewater supply, but was rendered useless as it received fuel draining from the site. It flooded the fire system pump house when it overflowed.
- There was a dependence on pumping liquids, which as a process is vulnerable to, for example:
 - inadequate pumping capacity;
 - failure of pumps on loss of power; and
 - inability to use pumps following release of flammable vapour.
- Some areas of unmade ground were not protected from liquids and one such area of the site included a soakaway.
- The effluent treatment plant included soakaways that were not identified in the safety reports or emergency plans.
