Buncefield: Why did it happen?

The underlying causes of the explosion and fire at the Buncefield oil storage depot, Hemel Hempstead, Hertfordshire on 11 December 2005

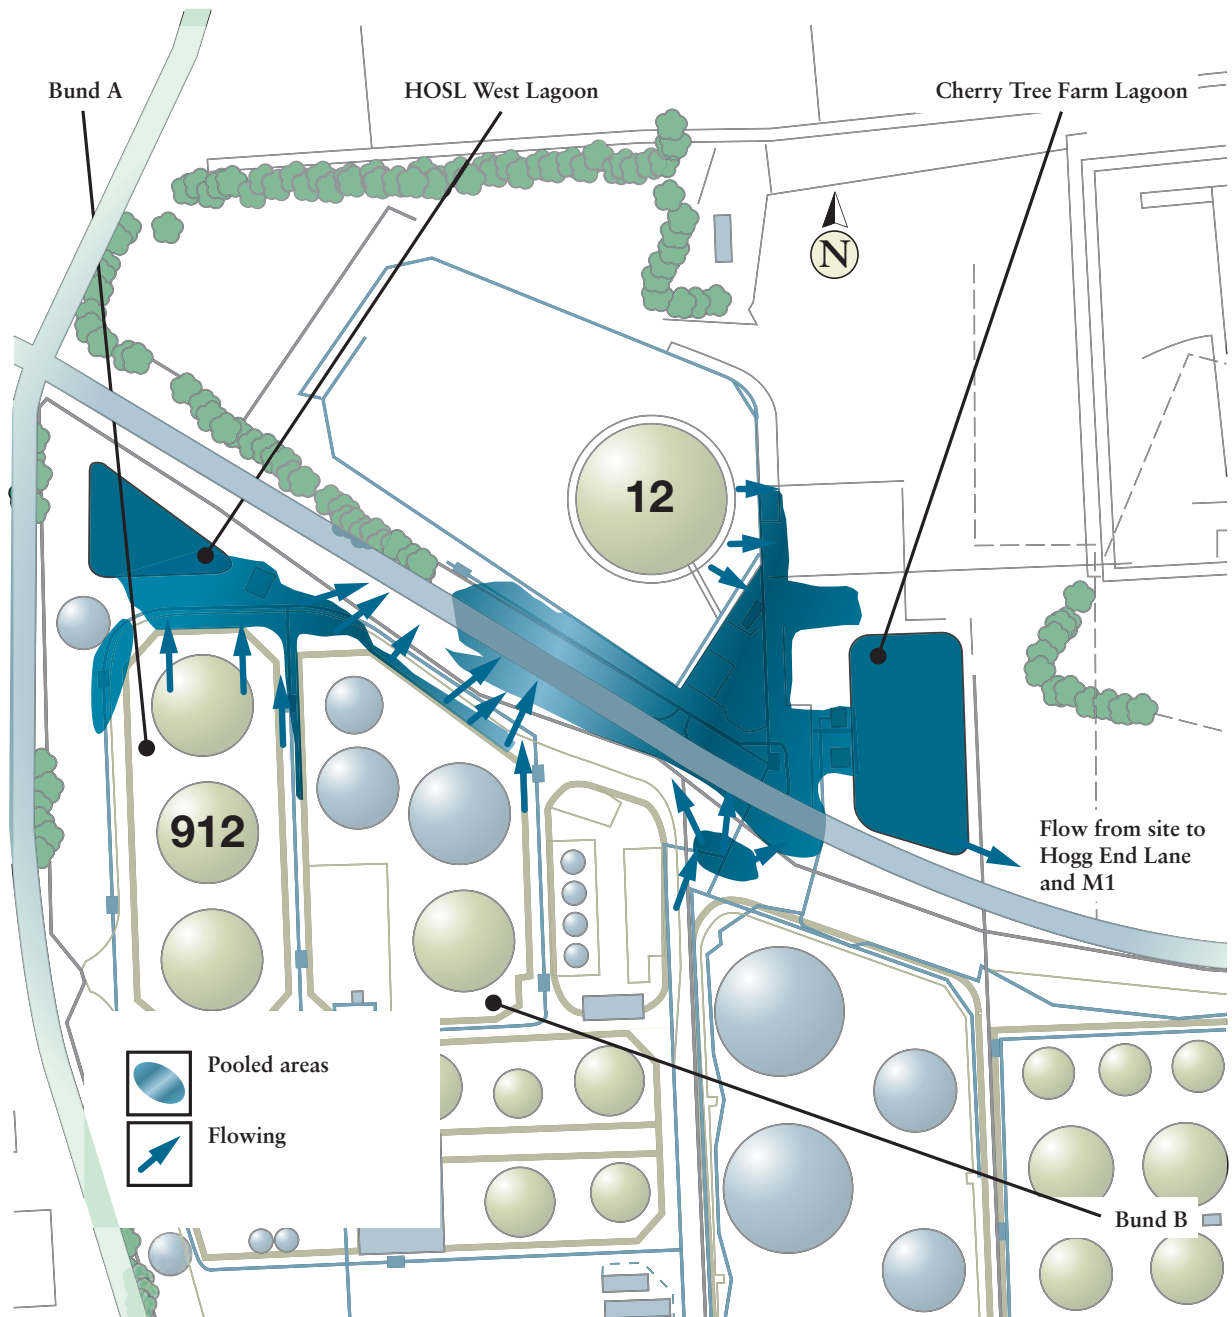
Figure 3 Layout of the Buncefield site showing flow of liquids

16 The fire lasted five days and large quantities of water and firefighting foam were used to bring the blaze under control. Fuel, water and foam spilled from leaking bunds formed a large pool of liquid to the east of BPA Tank 12. Liquids subsequently flowed down Cherry Tree Lane, past the roundabout into Hogg End Lane and as far the M1 motorway bridge, several hundred metres away.

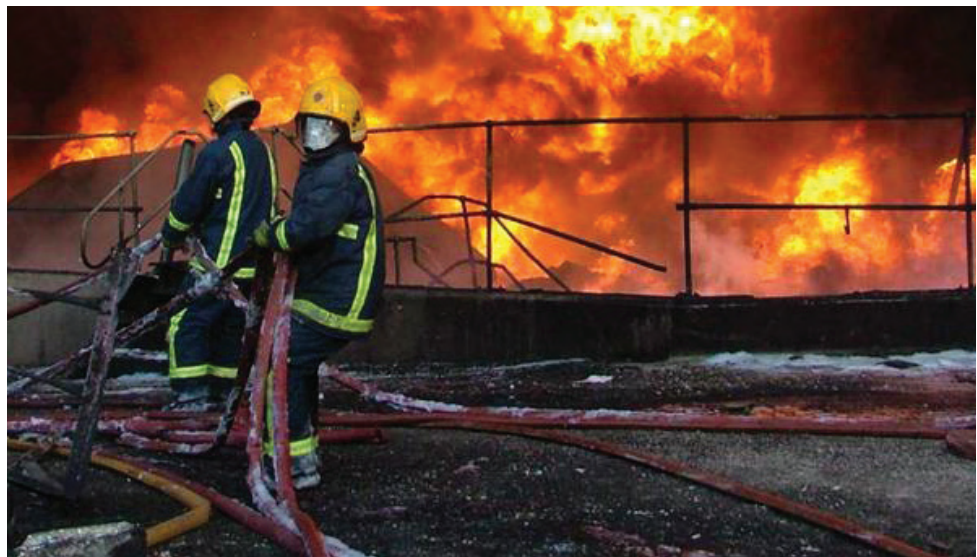
Figure 4 Firefighters tackle a blazing tank at Buncefield © Hertfordshire County Council

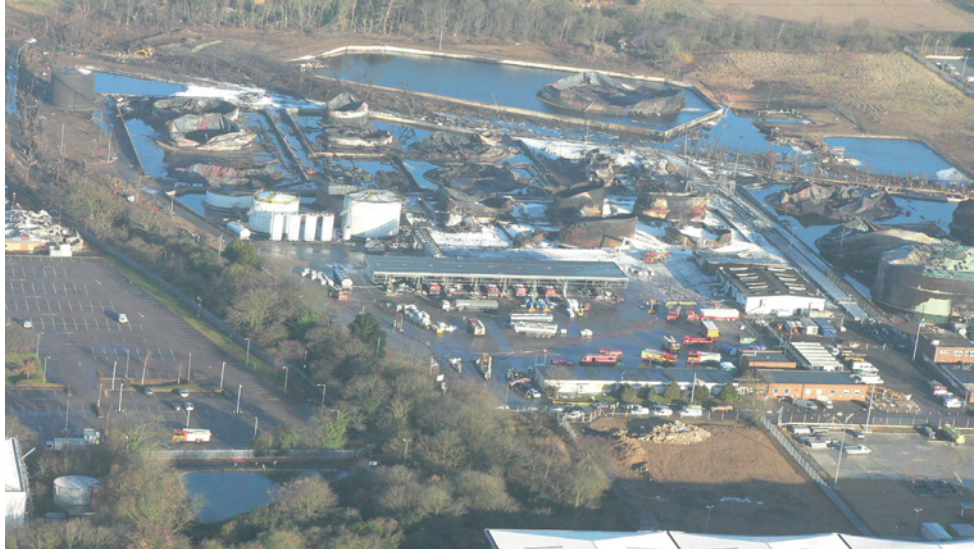
15 The severity of the explosion was far greater than could reasonably have been anticipated based on knowledge at the time and the conditions at the site. The devastation was enormous. Fortunately there were no fatalities but over 40 people were injured. The ensuing fire, the largest seen in peacetime UK, engulfed over 20 fuel tanks on the HOSL and adjacent sites and burnt for several days. Fire crews attended from many parts of the country. Fuel and firefighting chemicals flowed from leaking bunds down drains and 'soakaways', both on and off site. The environmental, social and economic toll was considerable. The human toll should not be underestimated; while no one lost their life some have yet to fully recover from the effect that the explosion had on their lives. The human effects may have been even greater had the event not occurred early on a Sunday morning when the adjacent industrial area was relatively quiet.

Figure 5 Part of the Buncefield depot after the incident © Chiltern Air Support
